On December 6, 2009, a customer was using the Citibank ATM located at 22000 Ventura Bl, Woodland Hills, CA 91364. He discovered a skimmer on the machine that he was using. He also observed a second skimmer on the machine next to him. The customer called the police and the skimmers were recovered.

It should be noted that the skimmer was designed to fit over the existing card slot and contained the card reader and the camera in one device.

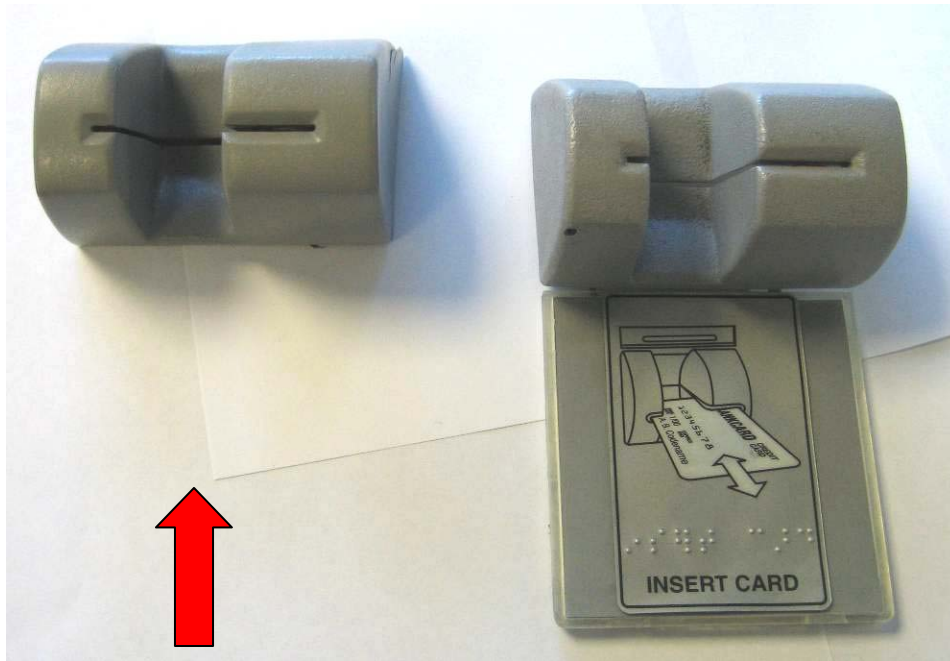
The real card reader slot.

The capture device

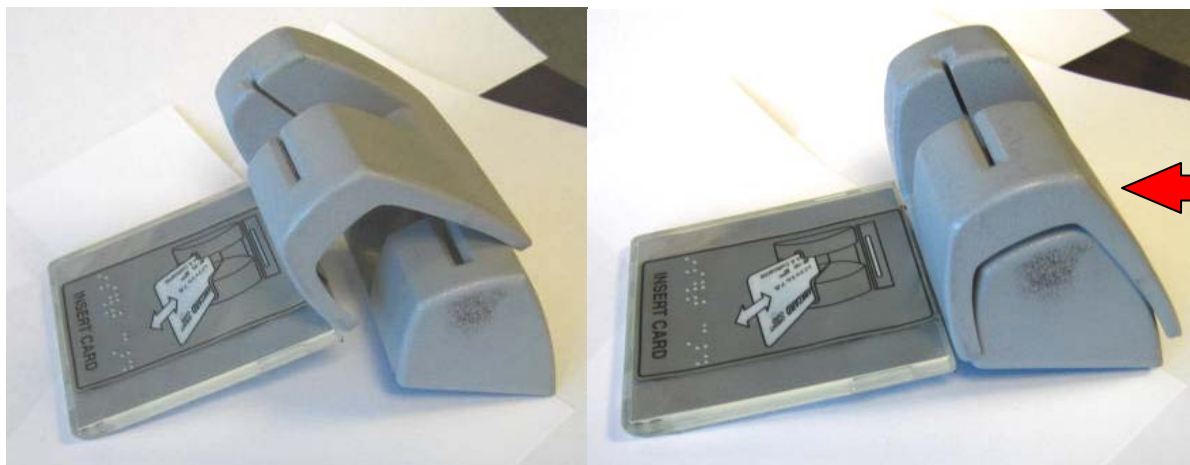
The side cut out is not visible when on the ATM.

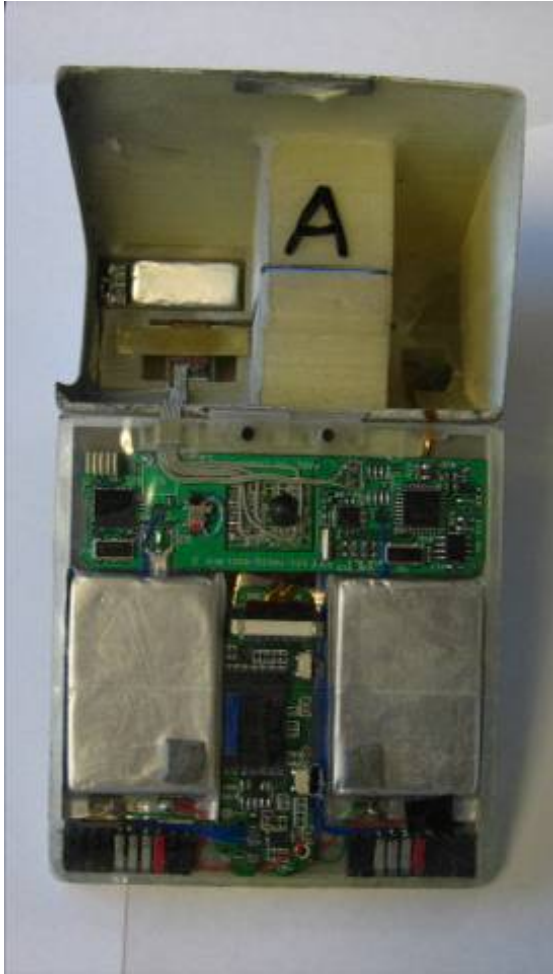
This is the back side of the device.

The card reader is on the left and the camera is tucked into the right side as shown below.

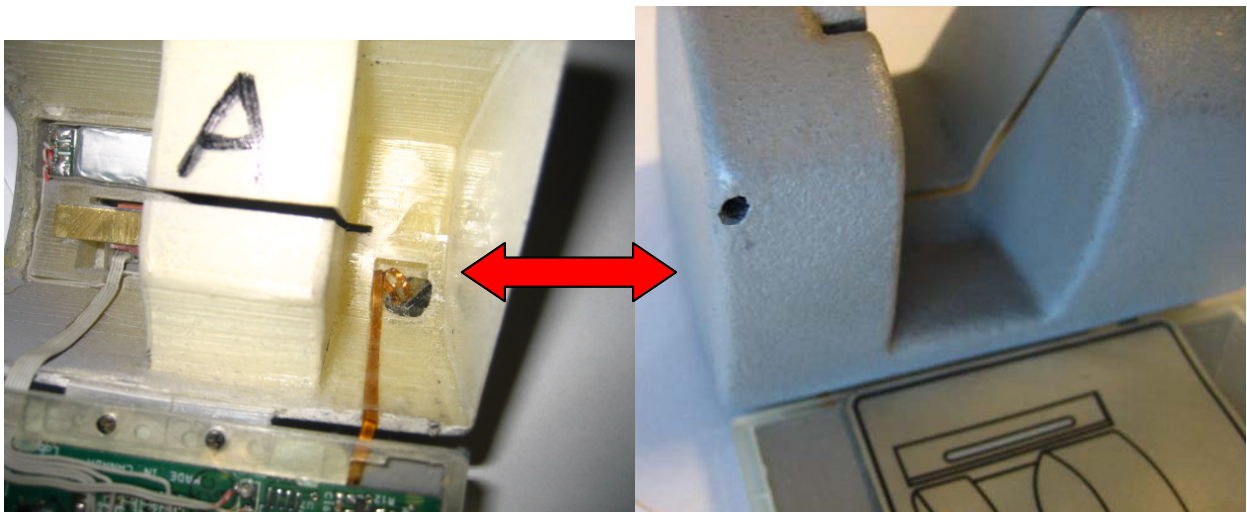
The device may have been constructed with parts from an MP3 Player.

It was attached with several small pieces grey double-sided tape

The part was well made and fit nicely over the original card reader.
